Revision Guide for AMD Athlon™ 64 and AMD Opteron™ Processors

| Publication # 25759 | Revision: 3.69 |
| Issue Date: September 2006 | |

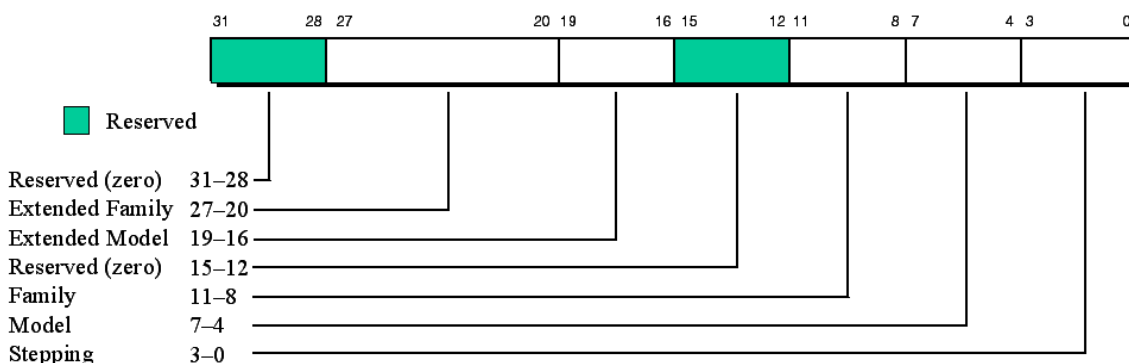
Figure 1 shows the format of the value returned in EAX by CPUID Function 1.

Figure 1. Format of CPUID Value Returned by Function 1
